IMMUNOSPOT®

Artifact Image Library

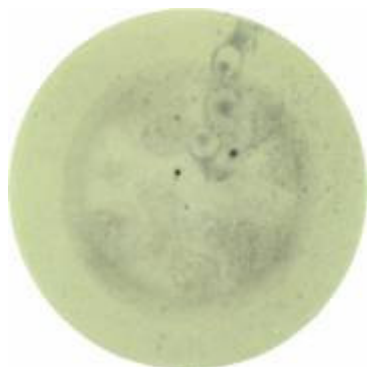
While pipetting, the pipet tip has touched the membrane

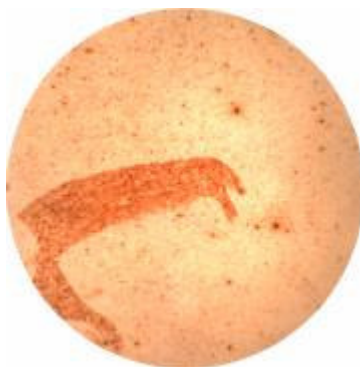
The coating antibody has shed from the membrane

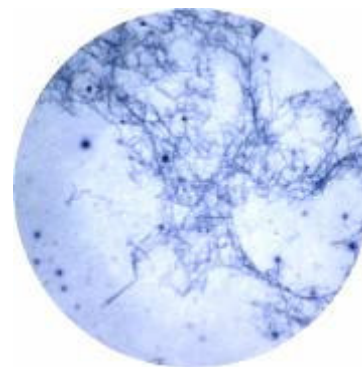
The plate has not been thoroughly dried, and fungi have grown

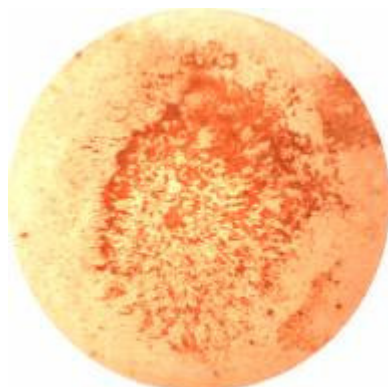
Proteins from serum or dead cells stick to the membrane

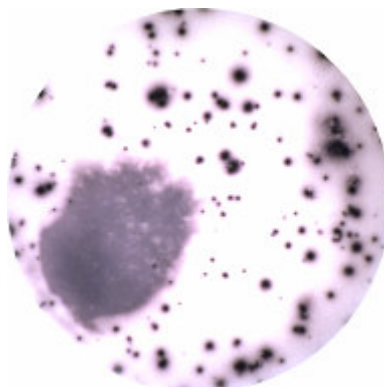
Membrane leakage due to manufacturing problems or Tween usage

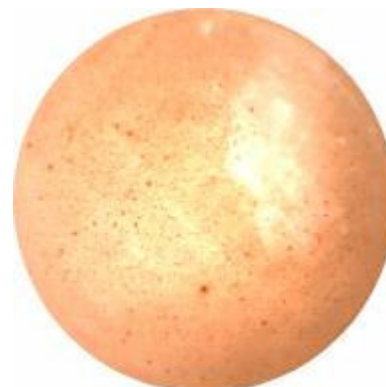
Uneven coating

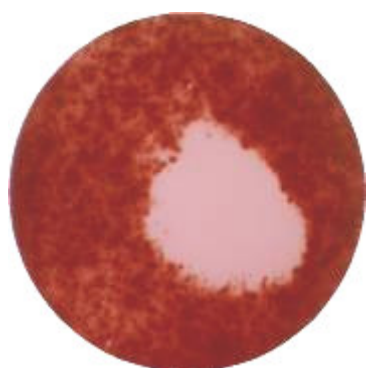
Uneven coating in positive control

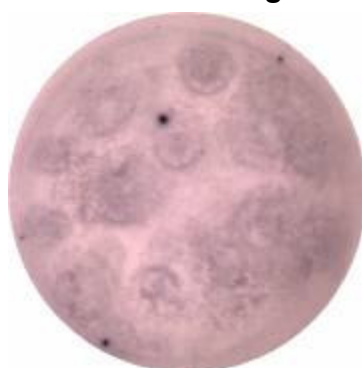
Plate was not thoroughly rinsed after developing and then dried flat: Residual color forms structures

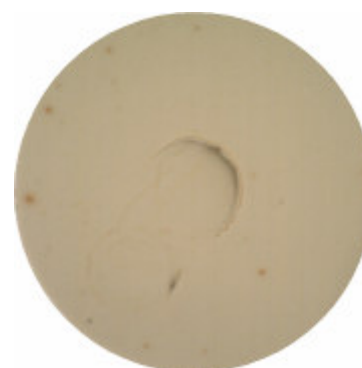
Pipet tip has pierced the membrane
